Resin Materials

Polyethylene Tank Inspection Guide

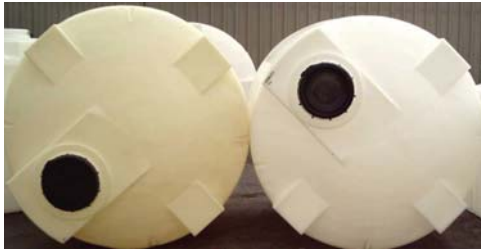
The picture on the right is a Linear HDLPE tank: Notice the "White color". Linear PE is a weldable, FDA approved material. Used commonly for day tanks and small chemical feed applications.

On the left, is a Crosslink HDXLPE tank: Notice the "off White / Yellow color". Crosslink polyethylene is used for large industrial bulk storage applications.

Polyethylene resins can be hard to identify after a tank has been installed. Common misconceptions are HDLPE is the same as HDXLPE. The following pictures will help you determine materials.

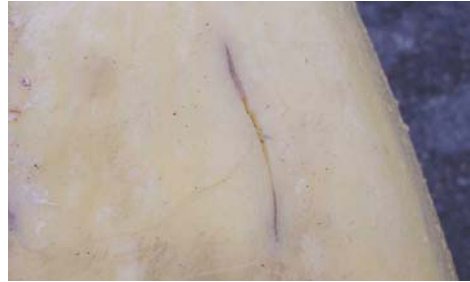
Polyethylene tanks are the most corrosion resistant method for storage of harsh chemicals. Improper plumbing attachments, Chemical and UV attacks are the most common causes for failure. Tanks can also fail due to age. Pictured below is a polyethylene tank that failed due to age. As you can see in the picture this tank has cracked a few inches above the tank floor. Typically cracks will develop near the tank base where the tank expands and contracts under normal operating conditions. When inspecting a tank always look near the tank's knuckle radius.

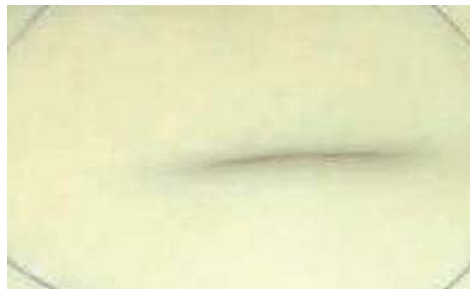
This picture is a chemical stress crack in a Crosslink polyethylene tank. Stress cracks normally develop at or near tank sidewall connections. A Crosslink tank will typically develop a stress crack prior to complete tank failure. This gives the end user warning to get the tank removed from service. Normally a Linear polyethylene tank will not give this type of warning before complete failure.

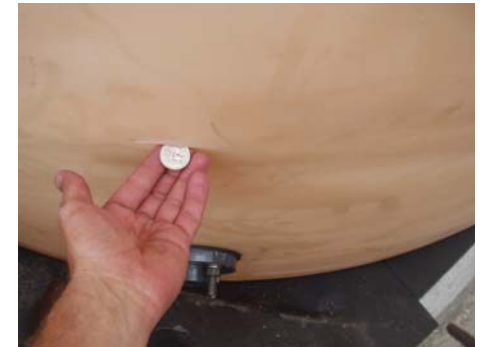
Polyethylene tanks are most commonly damaged when they are in transit or being off-loaded at a customer's site. Pictured below is a tank that has been gouged. This customer is using a quarter to gauge the penetration into the tank. If you can provide an accurate depth of a gouge, a reputable manufacturer can calculate the remaining thickness of the tank and give recommendations on how to proceed. A tank manufacturer or a qualified representative should be contacted immediately when damage is found.

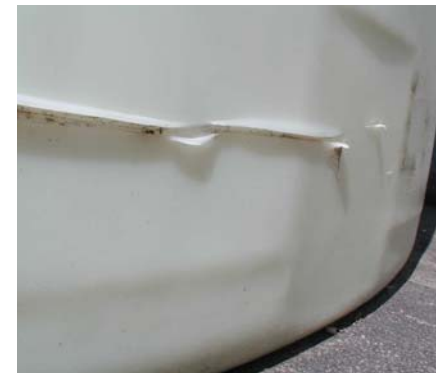
Tanks with damage similar to the picture shown below should be reported to the manufacturer, and evaluation should take place prior to the tank being placed in service.
